Addendum Ground Gas Monitoring Report

Report Number 77373/57629

Land off Chewton Street
Eastwood
Nottingham

Date: 24th May 2019

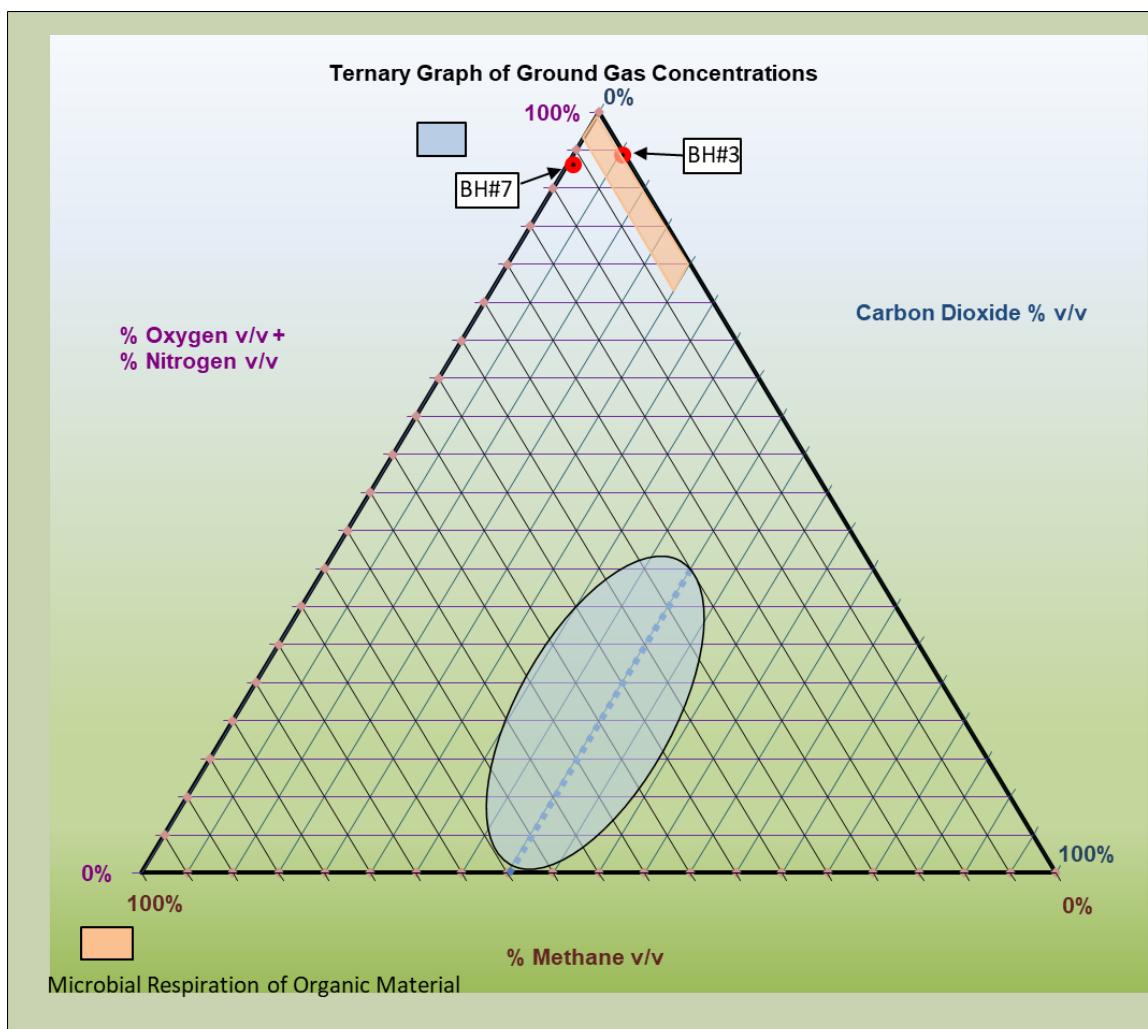
Figure 4.2 Ternary Graphical Plot of Readings for BH#3 and BH#7

particular. Flow rates of ingressing gases were shown to be particularly low and in general, very low in concentration and thus unattributable to landfill gas generation (see Figure 4.2).

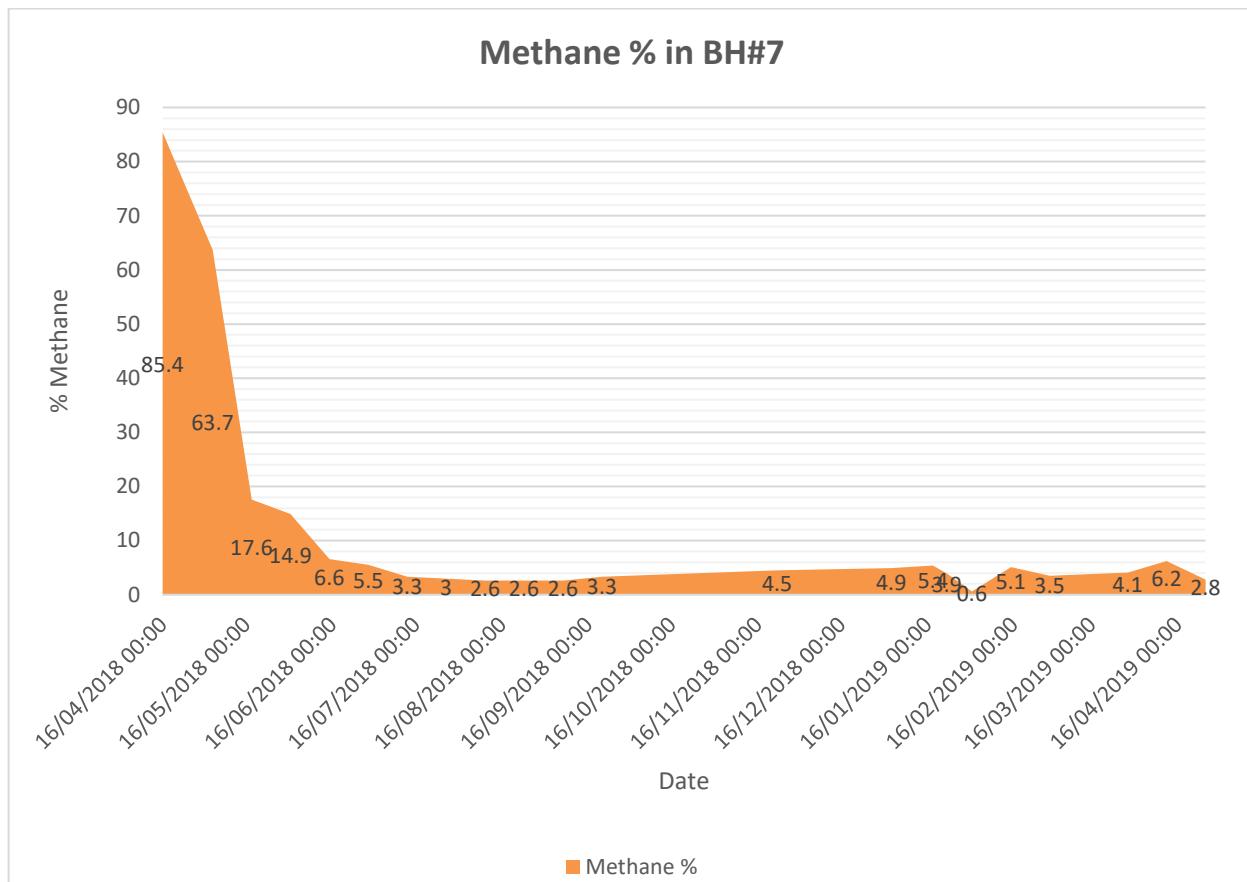
Figure 7.1 Methane Concentration in BH#7 over time

- 7.3 The initial results in BH#7 showed a significantly elevated Methane concentration that decreased substantially and steadied at levels of approximately 3 to 6% v/v concentration but all with a very low flow rate that does not appear to be correlated to barometric pressure fluctuations. Graphical representation of the concentration change over time is presented in the graph below:

- 7.4 The fact that no flow rate is noted suggest an intrinsic source of pocketed and trapped soil gas (likely in the clay-thin bands of coal-shale horizon; @ 1.20-2.40mbgl; see logs) with slow ventilation to the atmosphere over a period of c. 8 weeks. After this the level has varied between 0.6% and 6.6% v/v Methane, with no notable flow rate (either <0.1L/hr or at 0.1L/hr). The lithology was particularly carbonaceous with fragmented coals and shales. There is a strong argument for this deduction/correlation and further investigation may confirm this (or otherwise). The coals in this area were significantly more "dirty" (less bright and hard) than the coals found in Field Zone A (taken to be Waterloo coals).

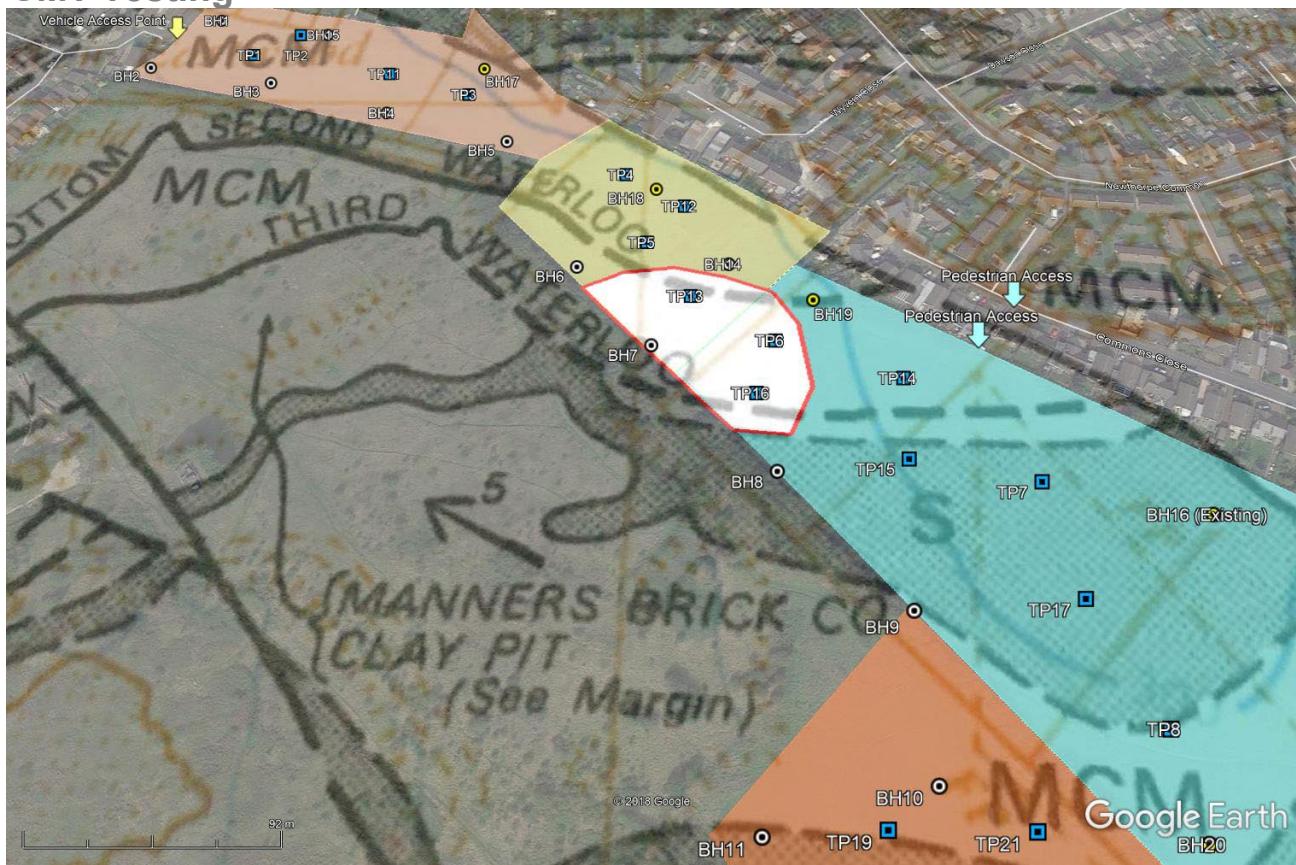
Figure 7.2 Approximated zone surrounding BH#7 (white) that presently requires further consideration

- 7.15 Presently this area is delineated by BH#6 (to the west), BH#14 (to the north) and BH#8 (to the east) as presented in Figure 7.2 below. It would seem to be possible to reduce this further as the Trial Pits TP#13, TP#6, and TP#16 do not show the same carbonaceous lithology. TP#16 shows weathered mudstone with (yellow) sandy pockets (possibly from the underlying sandstone). TP#6 shows yellow clays above the sandstone horizon and contains little to no carbonaceous material. TP#13 also shows weathering from sandstone horizons and there is also little carbonaceous material associated with this location.

- 7.16 Over the monitoring period the levels of methane in the borehole appear to have steadied around the 3-6% v/v concentration with no flow notable rate.
- 7.17 This suggests that the area needs further investigation or could be assigned to uses other than residential, such as less sensitive building Types (as per BS8485), although there will still be a requirement for the installation of applicable protective measures relating to CS2.
- 7.18 There is of course the option of further investigation by a developer to delineate the extent of methane around BH#7 by means of more gas monitoring on a tighter grid and increasing the resolution of monitoring points within similar response zones.

- 8.1 The site in general should be considered fit for the proposed Residential end use with due consideration given to protective measures (or further investigation) in and around the area of BH#7.

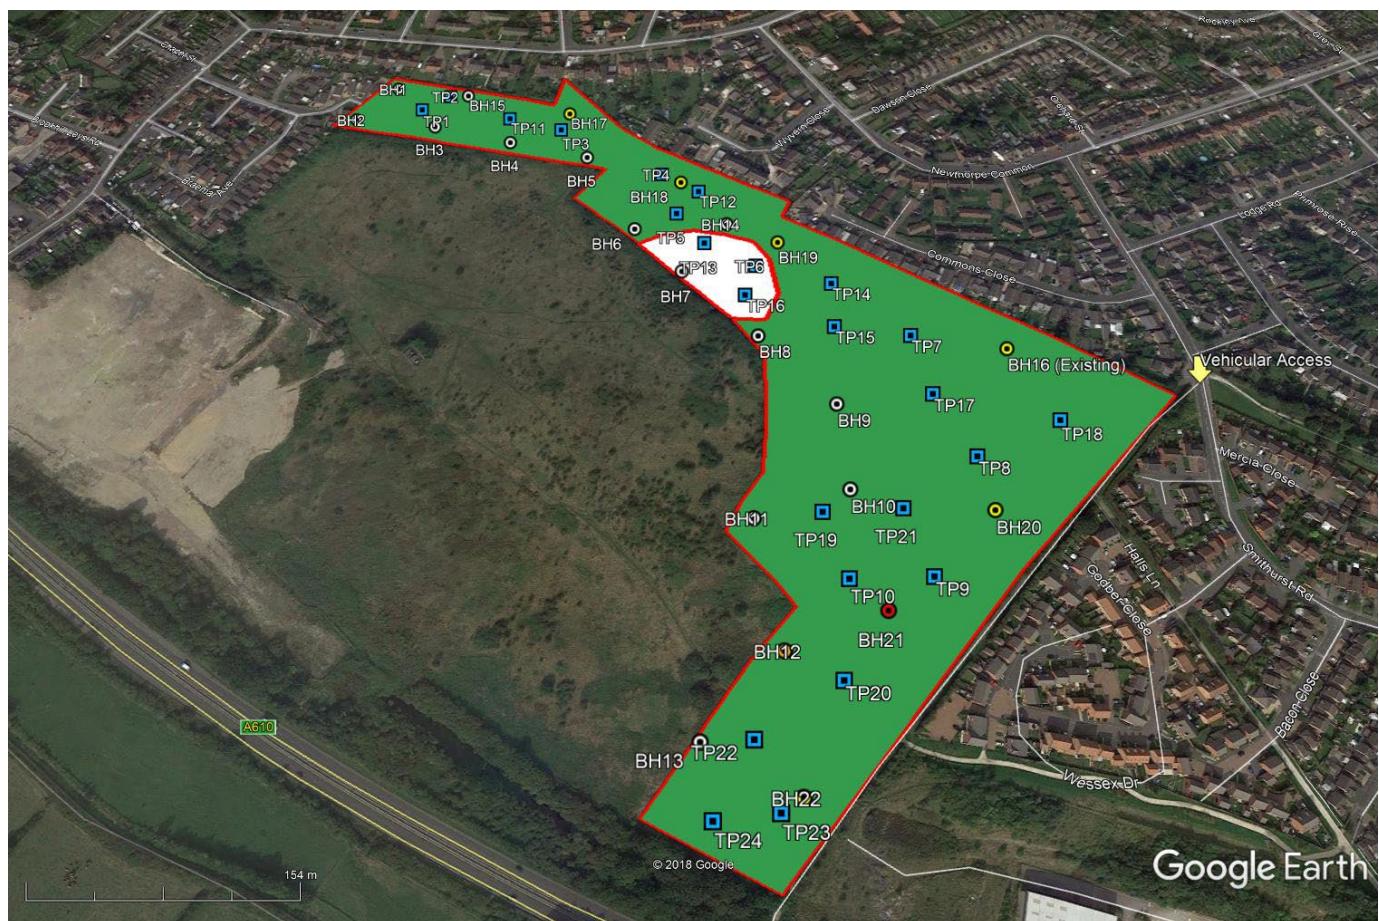
Figure 8.1 Green Area shows the general CS1 area (Green) and that relating to BH#7 (White).

- 8.2 No contamination has been shown to be present in the soil horizons (as per report 73336/57629).
- 8.3 The overall monitoring exercise showed that the vast majority of the site is considered as a CS1 LOW RISK Characteristic Ground Gas Situation with notably low flow rates of gas across all field zones with the exception of the area in proximity to BH#7.

- 8.4 There is no identifiable evidence of the ingress of "landfill gas" from the adjacent (and old) former Eastwood landfills.
- 8.5 From the observations and the evidence presented there is no suggestion of risk presented by the former landfills that relate to ground gas migration into the expected foundation response zones. This holds true for all boreholes, including the ones positioned on the boundary between the site and the former landfill.
