Broxtowe
Borough
COUNCIL

Beeston St John's Grove Conservation Area Character Appraisal

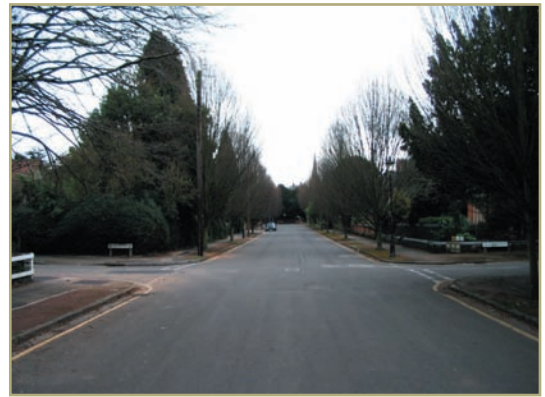
The area can be accessed from three directions. The main entrance is from the south, off Chilwell Road, the others are off Cromwell Road to the west; and Bramcote Road to the north. Cavendish Place and Vicarage Street both form culs de sac. Devonshire Avenue and Elm Avenue form the main arteries of the area. They run roughly north/south and provide long, tree-lined vistas.

Vista along Elm Avenue

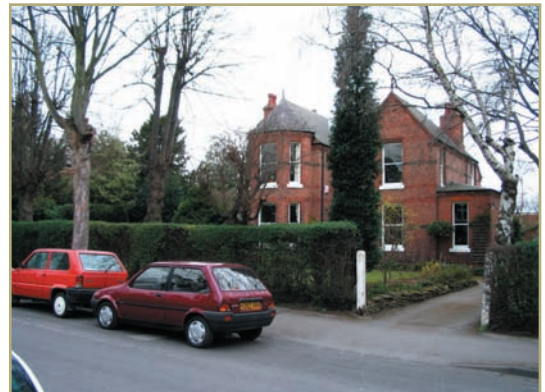
Late Victorian house in large garden

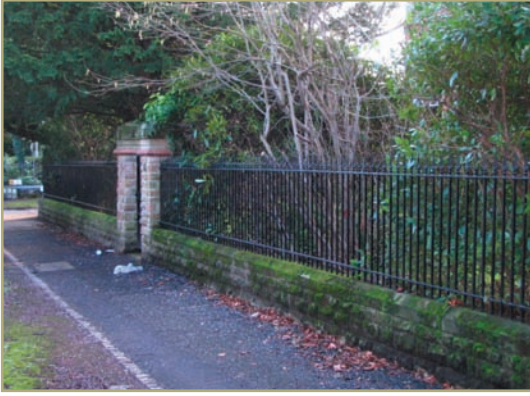
Characteristic boundary treatments: iron railings

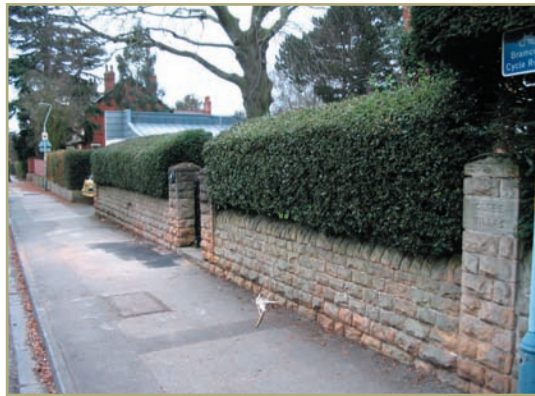
*Local stone walling and hedges*

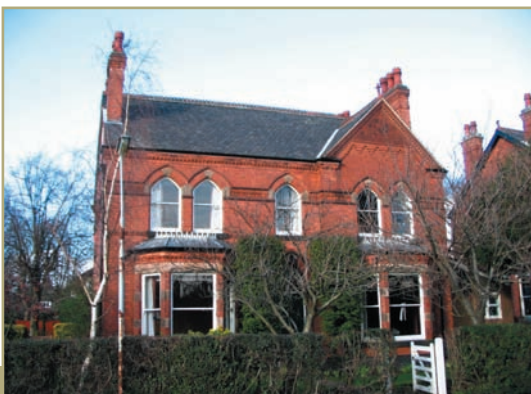
The area contains many fine examples of large, high quality Edwardian dwellings, both detached and semi-detached. They feature a variety of architectural detailing and retain a very high proportion of their original windows, doors and roof coverings. These features play an enormous part in preserving the historic appearance of the area, and combine with the mature gardens, boundary walling and traditional railings, to give much of the area a timeless quality, particularly along Elm Avenue. Elm Avenue also contains fine examples of large, high-quality inter-war housing, with their own characteristic details, such as circular windows.

Edwardian dwelling

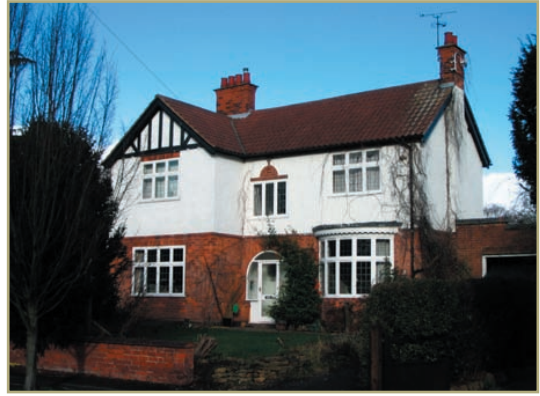
*Inter-war house*

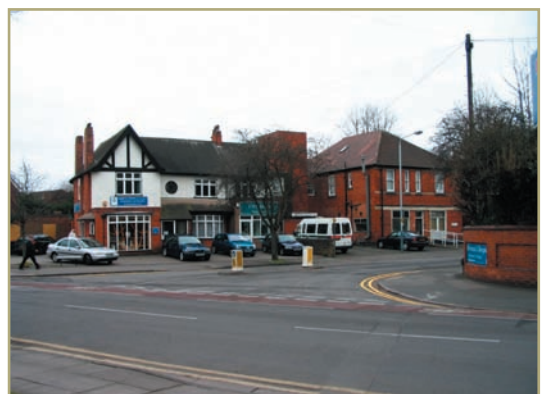
The quiet, residential character of the area has been eroded at the southern end of Devonshire Avenue, where it joins Chilwell Road. The commercial buildings between Newcastle Avenue and Chilwell Road have removed their front boundary walls and gardens to provide parking places. This has created a wide expanse of asphalt surfacing which gives this part of the area an urban character.

*Loss of front boundaries*

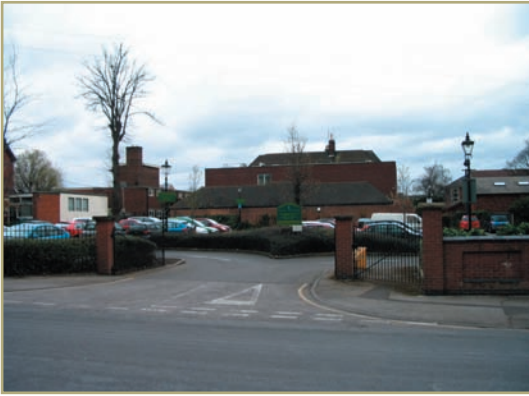
Visual leakage through car park

The other main erosive element of the conservation area is the Town Hall car park, which sits incongruously amongst the otherwise uniform layout of Devonshire Avenue in particular, and the conservation area as a whole. The car park is another wide open space which allows visual leakage through to the backs of buildings of neighbouring areas.

- Stricter control of advertisements, signage designs, and development of commercial properties at the Chilwell Road entrance
- Tree planting to screen open character of Town Hall car park

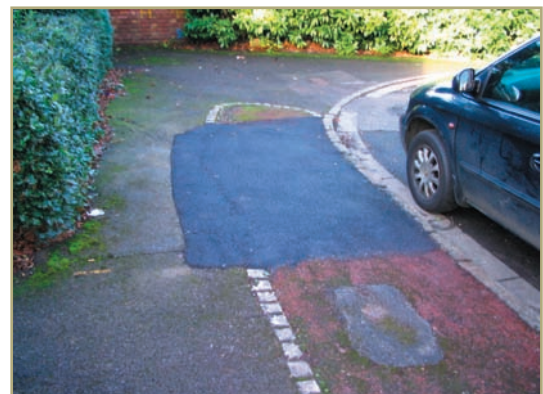
The setts also act as circular edging around the trees along the inter-linking routes of Glebe Street, Vicarage Street and Newcastle Avenue. They have suffered piecemeal loss over time through the backfilling of highway works, there are areas where they are missing, and they have been replaced with rectangular concrete setts in Cavendish Place. At the time of this survey, new gas mains were being installed and areas of setts were being replaced with asphalt. The borough council planning section was informed of this and action taken to halt the process, although those areas with missing setts still remain.

These setts are an attractive feature which should be retained, but many are loose, and in some places have been raised up by the tree roots to cause a potential trip hazard: in fact the trees are now growing too large to be contained within these features .

*Erosion: loss of stone setts*

- Reinstatement of stone setts and stone kerbs to footpaths
- Repair and maintenance of the historic street lighting
- Replacement of the utility street lamps with historic items to match those existing

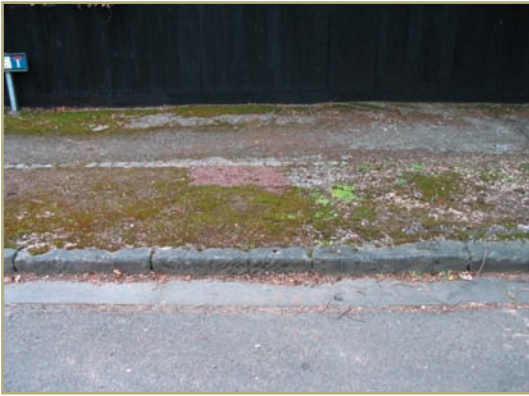
Some old weathered stone kerbs are still in place, but many have been replaced with concrete. The footpaths feature square stone setts which give a special character to the footways of the conservation area, making the streets distinct from those surrounding.

Surviving stone kerbs

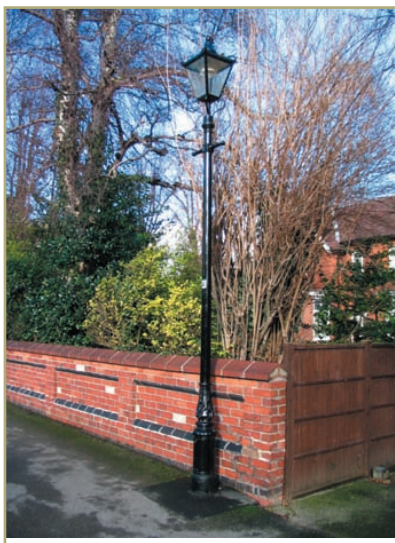
Historic, well maintained streetlamp

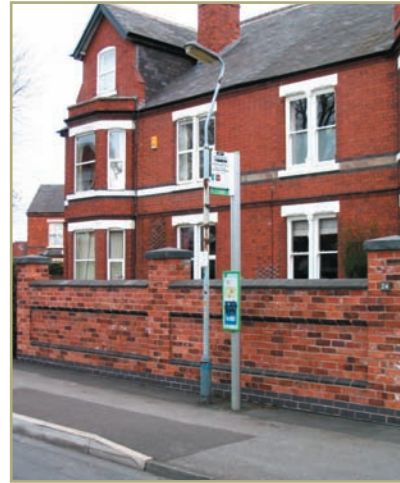
There are a variety of streetlamp styles, which vary from attractive historic and ornate cast iron examples, to tall concrete utilitarian designs, unsympathetic to the character of the area. Some of the older streetlamps appear to be either redundant or poorly maintained. They are rusting and detract from the otherwise well maintained public spaces. Aluminium posts for telephone wires similarly erode the character of the area.

Rusty streetlamp, with bus-stop adjacent

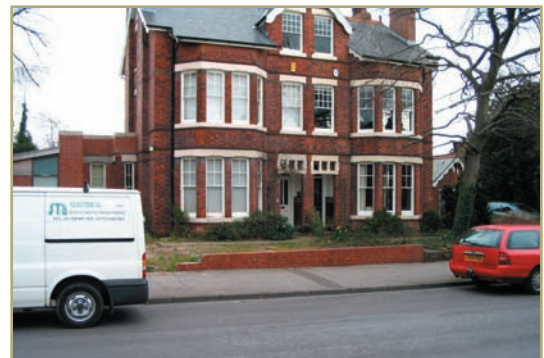
Although there are a variety of traditional treatments to the front borders of the properties, that include both brick and stone walls, railings, fences, and hedging; these would originally have created a variety but also a rhythm through repetitive use. Some more recent border treatments, however, are tending to erode this rhythmic nature through the introduction of too much variety in style and material. For example, the use of stained timber fencing of poor quality or design; rendered block walling; or simply the removal of hedging borders.

Eroded front boundary

- Reinstatement of traditional front boundary treatments to repair rhythm of street frontages
- Simple regular property maintenance, such as the annual clearance and repair of rainwater guttering and a 5 yearly repainting of the timber windows, doors etc.

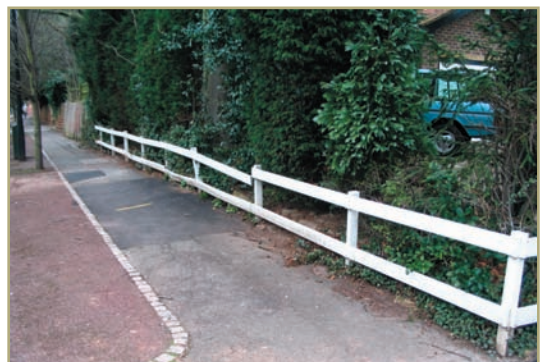
Post & rail fencing in UPVC
