Addendum Ground Gas Monitoring Report

Report Number 77373/57629

Land off Chewton Street
Eastwood
Nottingham

Date: 24th May 2019

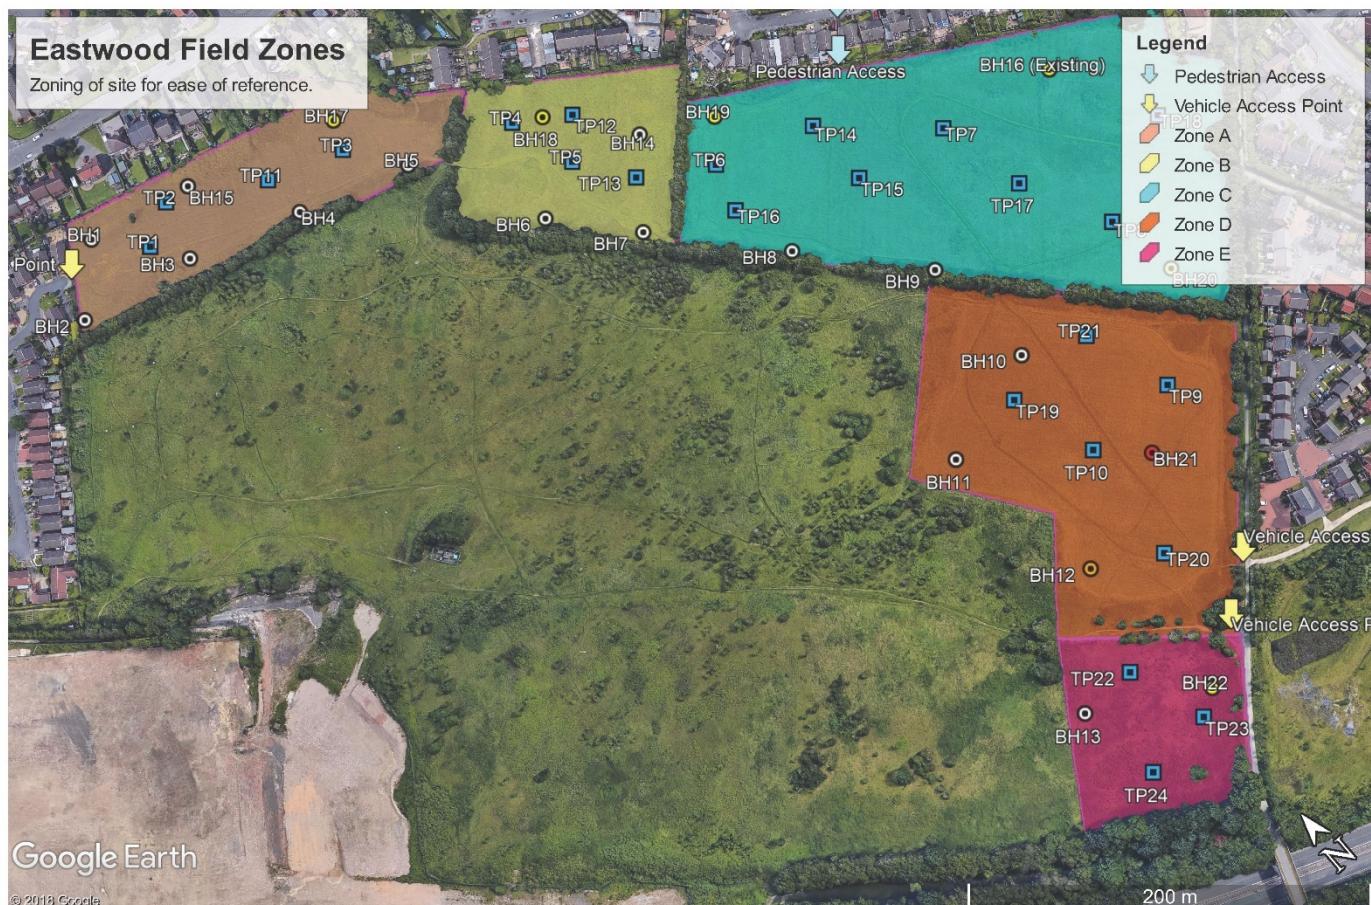
Figure 4.1 Field Zones of the Eastwood Site.

- 5.3 BH#7 (clay carrying very broken shale and coal) exceeded the 1.0%v/v threshold for Methane.
- 5.4 There were a number of occasions that after heavy rain the boreholes, in most if not all, in Field Zone B were flooded. This was also true for BH#1 in Field Zone A, BH#19 in Field Zone C, BH#11 in Field Zone D and also, less frequently, BH#12 in Field Zone D.

- 7.13 For Field Zones B and C the only exceedance is that which is noted in BH#7. This could well be due to the significant amount of fragmented shale and coal present as there is no apparent flow rate attributed to the borehole and the results appear to be largely independent of barometric fluctuations.
