# Church Street & Nottingham Road Conservation Areas Character Appraisals

# 3.0 Church Street conservation area

# 4.0 Nottingham Road conservation area

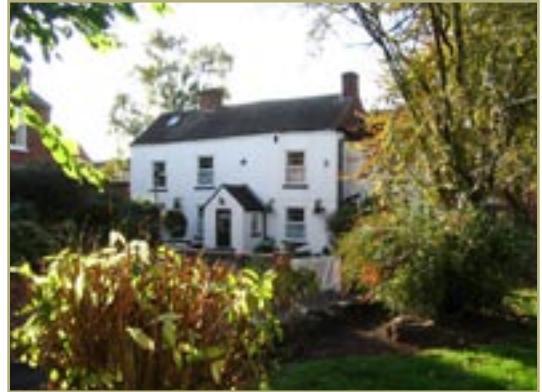
House in Church Lane

In the western half of Church Lane, the character and appearance has been eroded by unsympathetic late-20<sup>th</sup> century developments. The youth centre, church hall and a large two-storey, flat-roofed extension to a late 19<sup>th</sup> century industrial

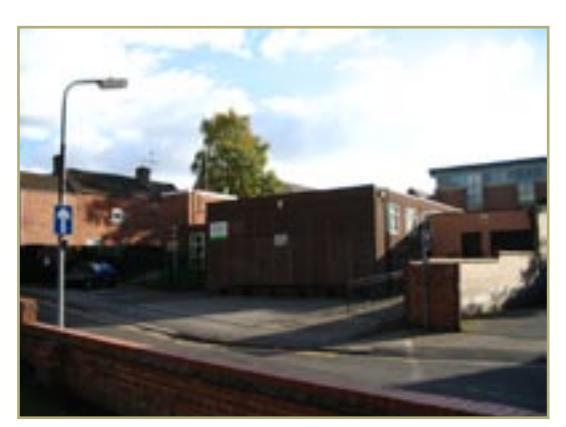
Youth centre

building, combine to damage the western entrance to the conservation area, off Frederick Road. The youth centre breaks the building line of the lane and both it and the church hall are constructed of brick and roof coverings which are unharmonious to the adjacent historic buildings. The large extension, though built of red brick, is too tall and wide for the lane, dominating its entrance.

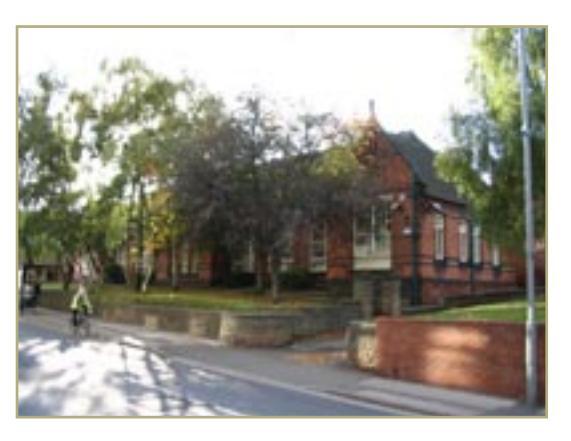
Arthur Mee Centre, Church Street

To the south of Church Lane, the conservation area encompasses the buildings of The Arthur Mee Centre, which front Isaac's Lane and Church Street. Named after the famous local author, this group of buildings was originally the Stapleford Boys' School and represent a good example of Victorian Board School architecture. They date from the late 19<sup>th</sup> century and are constructed of orangeyred brick with blue brick and limestone detailing, and have steeply pitched slate roofs. They continue in educational use as part of the Castle College.

The buildings are generally in good condition and contribute positively to the character of the conservation area. Their materials of construction, along with their low sandstone boundary walling, provide a good reference point for the design of new development within this area. The grassed area to the Church Street frontage is an attractive feature but the tree-planting, although softening the streetscape, obscures the building façade. A reduction in the number of trees would enable more of the building to be appreciated.

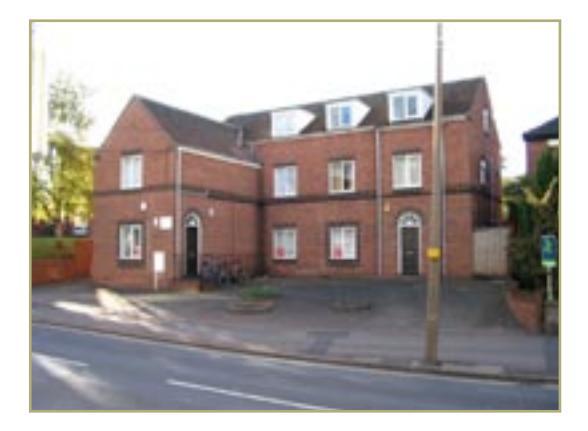
Flats in Church Street

Two other structures front the west side of Church Street in this area: a small complex of flats and a late 19<sup>th</sup> century semi-detached dwelling. The flats, in general, are not out of character with the area with regard to scale and materials. Their appearance is spoilt, however, by the dormer windows to the front elevation and a harsh expanse of hard standing. Use of low sandstone boundary walling and planting, exhibited by both neighbouring properties, would reinstate continuity to the street frontage and soften the impact of these buildings. The semidetached house is generally in keeping with the area's character.

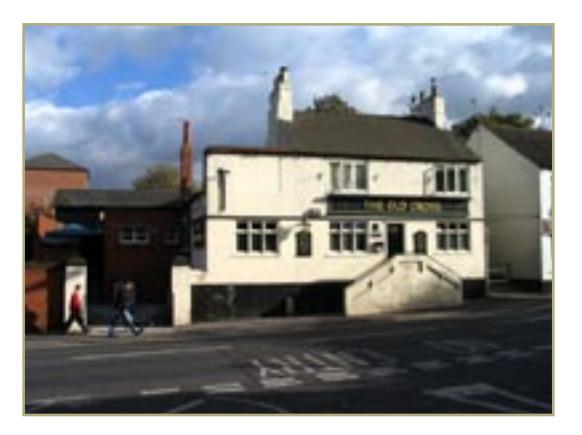
#### Old Cross public house

To the north of these terraces is the Old Cross public house, dating from the 19<sup>th</sup> century, and car parking area. The public house retains its slate roof, chimneys, and some original casement windows to its ground floor. It has also been rendered and is probably of a similar date to the terraced housing. It has a selection of outbuildings that further add to the character of the area.

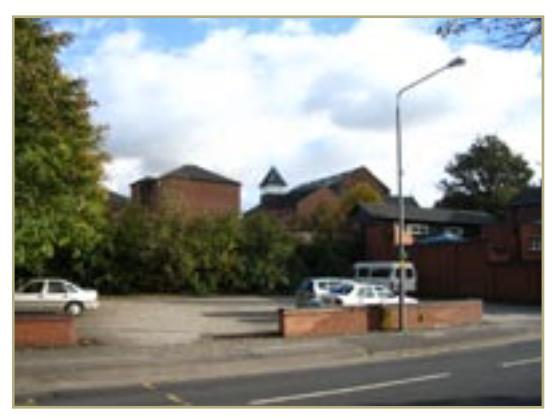
There are views out northwards to Kayes Court from the elevated position of Church Walk. Kayes Court appears to be a fairly new development of apartments. It designers have made an attempt to blend it into its surroundings of 19<sup>th</sup> century domestic, religious and industrial buildings, and to a large extent they have been successful. Only the positioning, proportions, scale and colouring of the windows and doors detract from its overall appearance. Car park next to public house, showing interesting roof-scape

The pub car park is a simple expanse of pale grey asphalt behind a low red brick wall with blue brick copings. This simplicity works well but could be improved perhaps by lessening the width of the vehicle access to enable a better length of walling and so reinstating the continuity of the street frontage boundary.

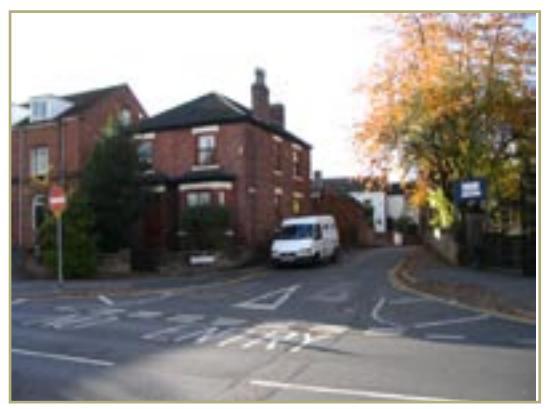
#### Extensive road markings

The great width of Church Street, in comparison to Church Lane, combined with extensive road markings and the width of the eastern entrance to Church Lane, erodes the village-like character of the conservation area. There is a sense that the area is divided by the street, with the church on one side and the pub on the other. The area is dominated by the highway and the speed of the traffic, which further erodes the connectivity and character of the area. If this eastern entrance to Church Lane was narrowed and grass verges introduced to the front of 39-47 and 48 Church Street, a continuity of green frontages from the Arthur Mee Centre to the church yard would be formed, and a village-like character reintroduced.

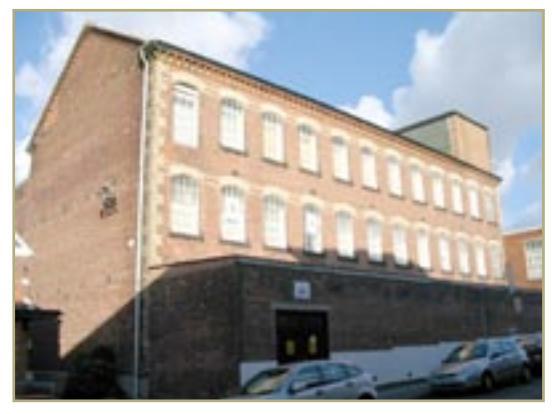
Silk mill, Albert Street

The former silk mill in Albert Street, currently occupied by the Castle College, is an attractive late 19<sup>th</sup> century industrial building with fine architectural details to its windows, eaves, and gables. It is a landmark structure and as such it provides a powerful reminder of the importance of the textile industry in Stapleford.

The mill illustrates the development of this industry from the framework knitters' cottages in the nearby Nottingham Road conservation area. Its interesting roofline incorporates a glazed tower with pyramidal roof which can be seen from both Church Street and Nottingham Road.

The building possesses the characteristics described in statements 4, 6, 7, 8, and 9 of the English Heritage criteria reproduced in appendix 2, and should be included within the conservation area.

Extending the conservation area boundary along the north side of Albert Street would enable some control over the future of this building, and would also encompass the neighbouring 19<sup>th</sup> century Baptist church, Sunday school and a short terrace of domestic dwellings, dated 1880 (Map 3).

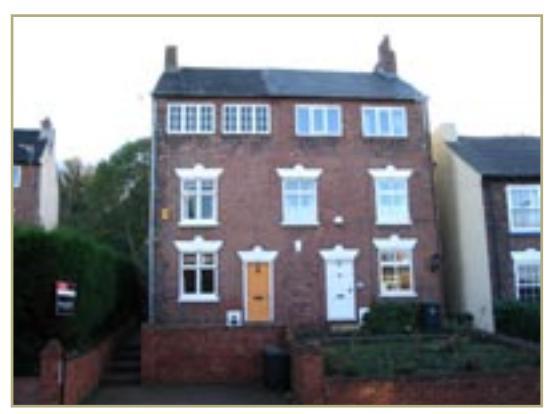
Framework knitters cottages

To the north of the road are two knitters' cottages (119 & 121) in the form of a three storey semi-detached building. They sit directly behind the footpath and are flanked by late 19<sup>th</sup> century two storey semi's, set back a short distance from the footpath. The front boundaries of the latter have been removed to enable carparking, which has broken the building line. One other building falls within the conservation area on this side of the road: a 1930's detached house with a single storev extension housing a fish bar. A wide expanse of hard standing surrounds this building. Apart from the knitters' cottages, all of the buildings have had replacement doors and windows fitted, which are unsympathetic to their original character.

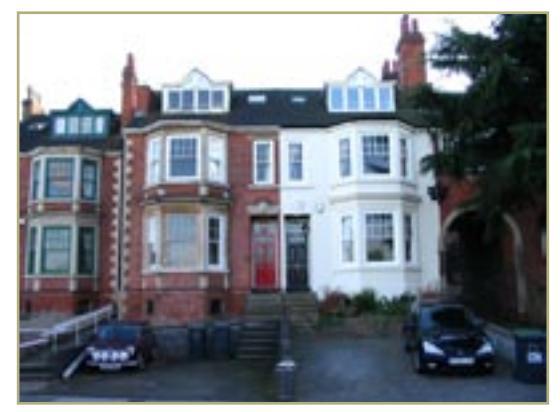
Most of the boundaries have been removed to provide parking spaces. The large, late Victorian buildings to the eastern end of the area, which have been converted to apartments, are particularly affected. Various materials have been used to create hard-standing and low dividing walls. This has broken up the unity of this large group of contemporaneous buildings. Other remaining front boundary walls are in poor condition.

Differing treatments to boundaries has damaged continuity

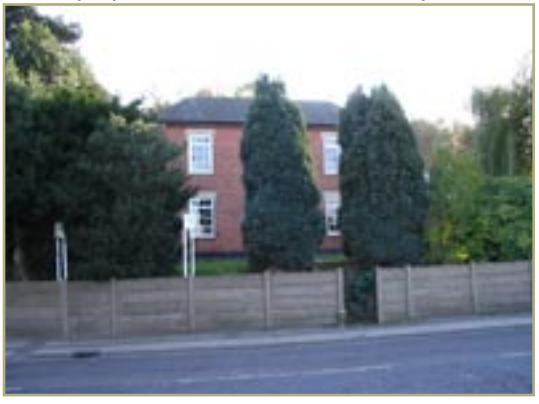
The western end of the conservation area contains more individual housing of the 19<sup>th</sup> and 20<sup>th</sup> centuries, set further back from the road within gardens containing large trees and shrubs. These houses are less overwhelmed by the road and many are not clearly visible. They tend to blend into the background of the trees which cover the high ground to the rear. Number 100 at the extreme west end of the area has a very unsympathetic design of front boundary wall, in the form of prefabricated concrete panels.

Unsympathetic concrete boundary wall

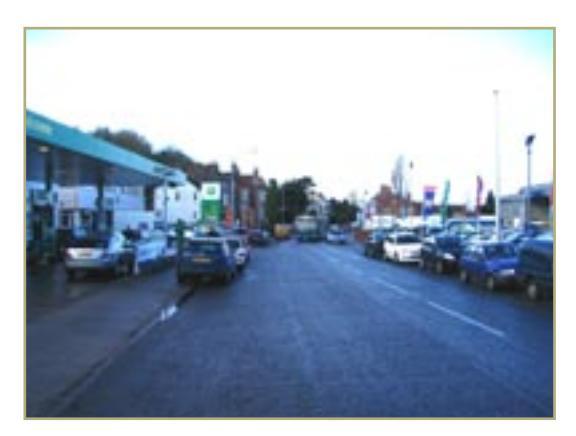
Eastern entrance to conservation area

Two large car garage/dealerships have already been developed on both sides of Nottingham Road on the eastern boundary of the conservation area. These have seriously eroded the setting and the eastern entrance to the conservation area. The redevelopment of the above sites needs to be given very careful consideration so that the setting of the listed buildings and conservation area is not harmed further.

Nottingham Road conservation area is dislocated from the rest of Stapleford and any development of these gap sites should aim to connect it to the settlement. A mixture of two and three storey structures which take a lead from the appearance of the listed framework knitters' buildings and their tree-rich gardens could work well here.
